MIDDLE BRANCH DAM

PHASE I INSPECTION REPORT

NY 00034

Date: August 17, 1978

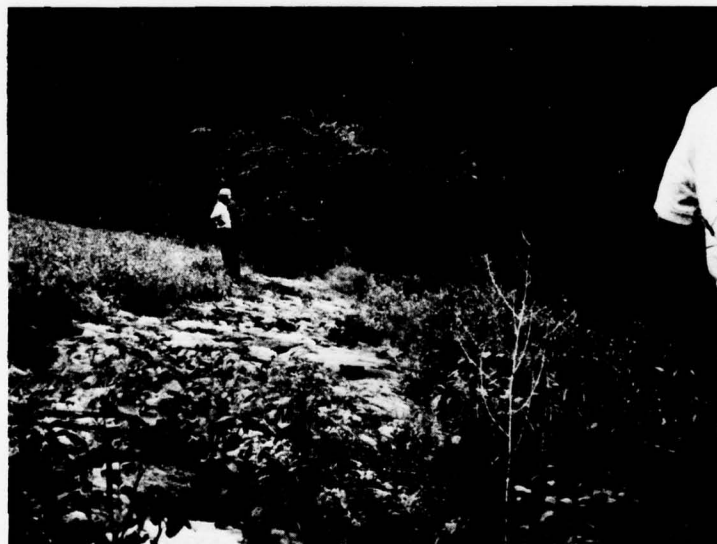
TOE OF DOWNSTREAM SLOPE
